SANDIA REPORT

SAND2007-2345

Failure Analysis for the Dual Input Quad NAND Gate CD4011 Under Dormant Storage Conditions

N. Robert Sorensen

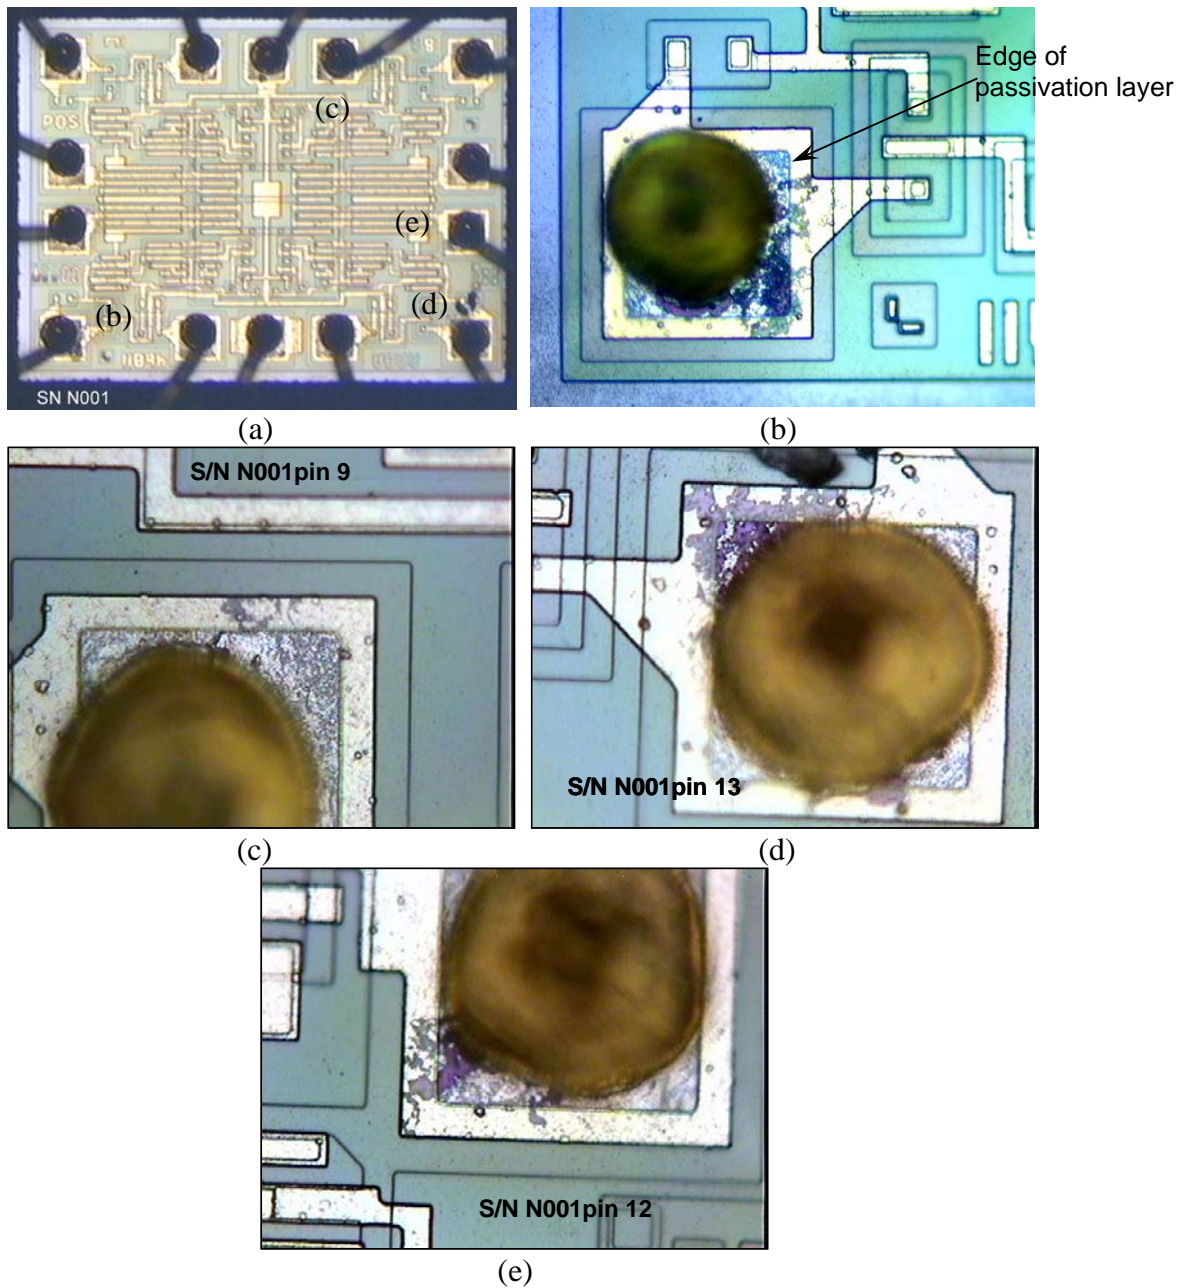
All of the parts that exhibited electrical failure were examined optically for evidence of corrosion. Figure 3 shows optical images of part S/N N001 following the decapsulation process. Electrical testing resulted in many failures with no obvious trends being established. Corrosion was observed on many of the bondpads (1, 3, 4, 9, 12, 13 & 14). Three of the bondpads are shown (9, 12, and 13). Attack of the bondpad is visible, although the Al has not been entirely consumed. In addition, corrosion has progressed

beneath the passivation layer at the edge of the bondpad. No evidence of trace corrosion was found.

Figure 3. Optical micrographs of Al bondpads for CD-4011 S/N N001. Note attack of Al and progression of attack below the passivation layer.

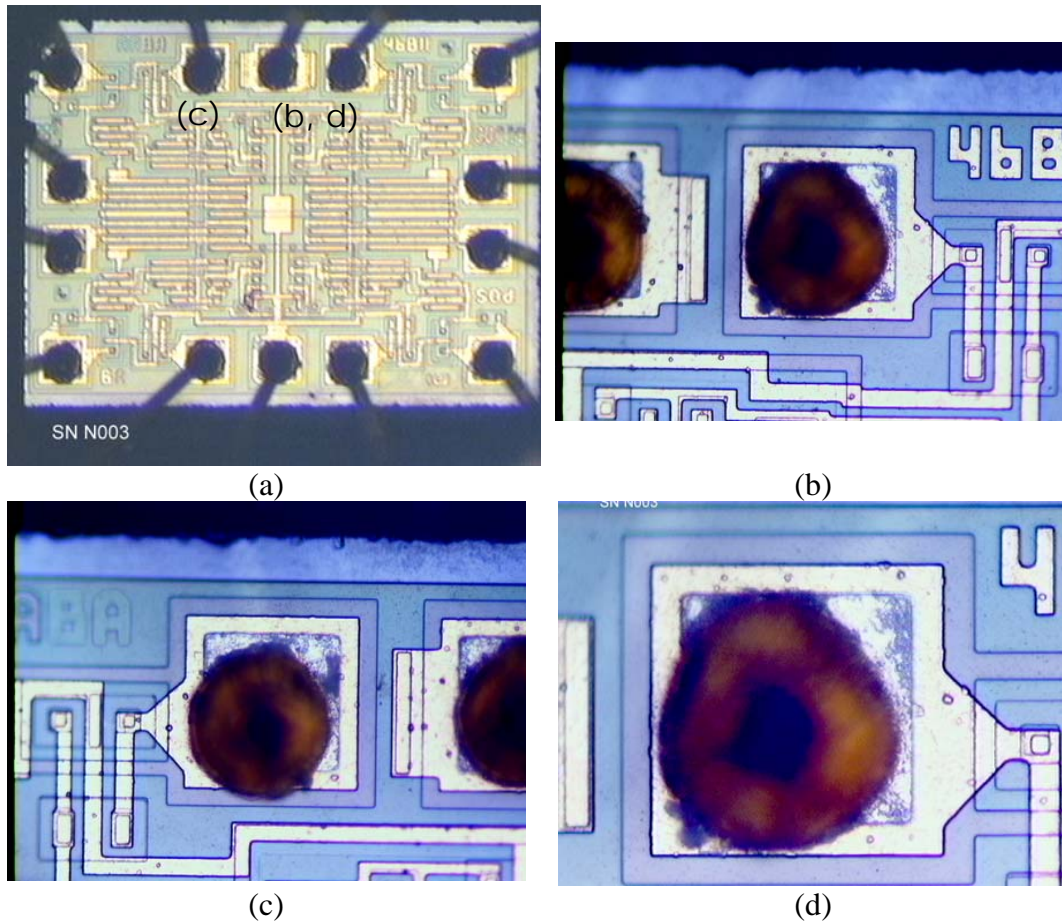
Figure 4 shows images of device N003. Numerous electrical failures were observed, with no obvious trends with respect to observed corrosion. Following the decapsulation process corrosion was observed on bondpads 5 and 6. In this case, the bondpads were almost completely consumed. Corrosion products are visible on the die surface. No evidence of trace corrosion was found.

Figure 4. Optical micrographs of Al bondpads for CD-4011 S/N N003. Note attack of Al and progression of attack below the passivation layer.

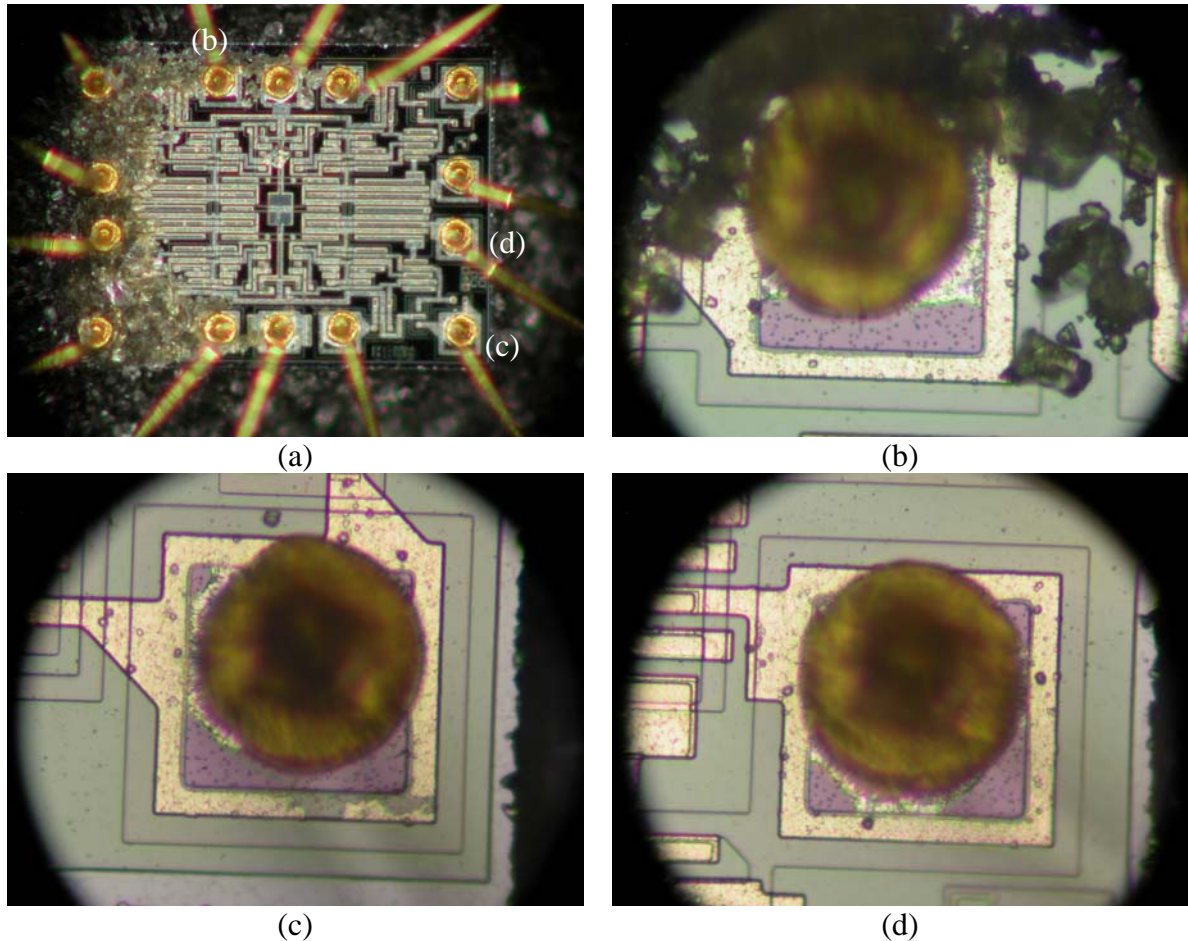
Device S/N N005 exhibited an open circuit on pin 1. Images from this device are shown in Figure 5. During the de-cap process, the epoxy was not completely removed from the die surface and corrosion at these location could not be verified optically. Corrosion is visible on several of the bondpads. In general, it stops at the passivation layer, but some undercutting of the passivation layer is visible (c). No evidence of trace corrosion was seen.

Figure 5. Optical micrograph of CD-4011 S/N N005. Labels on the image in (a) indicate location for individual bondpads imaged in (b)-(d).

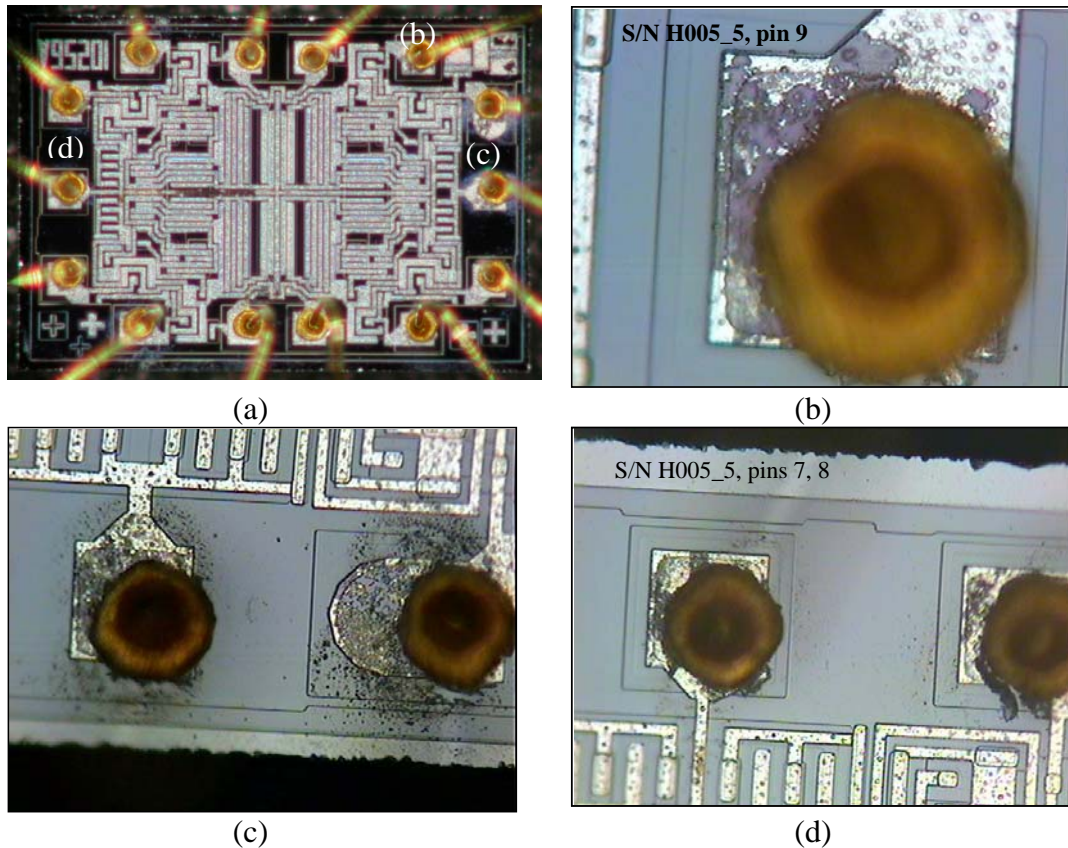
Sample S/N H005 exhibited opens at pins 8 and 9 during electrical testing. Optical microscopy (Figure 6) revealed corrosion on pins 1,2,3,7,8,9,12,13 and 14. As seen in the figure, extensive attack of the bondpads was observed. Corrosion products are visible on the die surface. Although only two of the bondpads indicated open circuit, many more were corroded which would likely lead to additional open circuits in the future. No evidence of trace corrosion was seen.

Figure 6. Optical micrographs of Al bondpads for CD-4011 S/N H005. Extensive attack of the bondpad and corrosion products on the die surface can be seen. Labels on the image in (a) indicate location for individual bondpads imaged in (b)-(d).

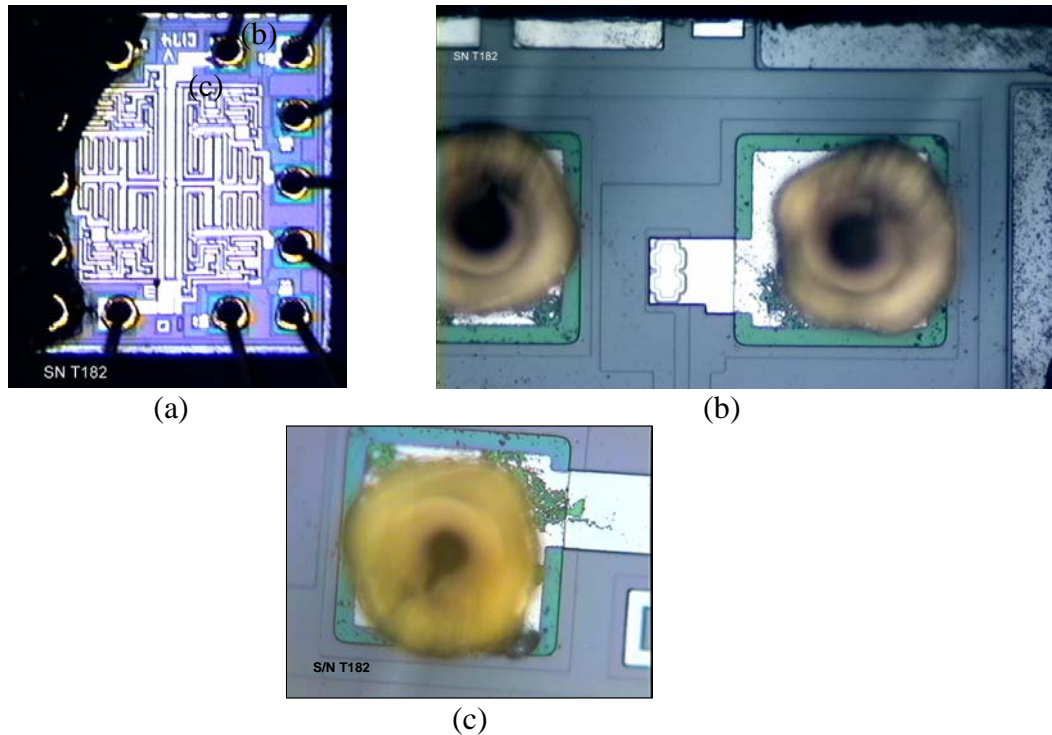
Figure 7 shows images from S/N T182. In electrical testing, several of the leads were in the wrong state. Visual analysis indicated corrosion of bondpads associated with pins 6 and 7. Those connected to pins 8 through 12 were obscured by residual epoxy, and thus, were not visible. In general, the die is very clean and shows no evidence of trace corrosion.

Figure 7. Optical micrographs of Al bondpads for CD-4011 S/N T182. Attack of the bondpad can be seen with corrosion progressing beneath the passivation layer. Pins 6 and 7 were affected. Labels on the image in (a) indicate location for individual bondpads imaged in (b)-(c).

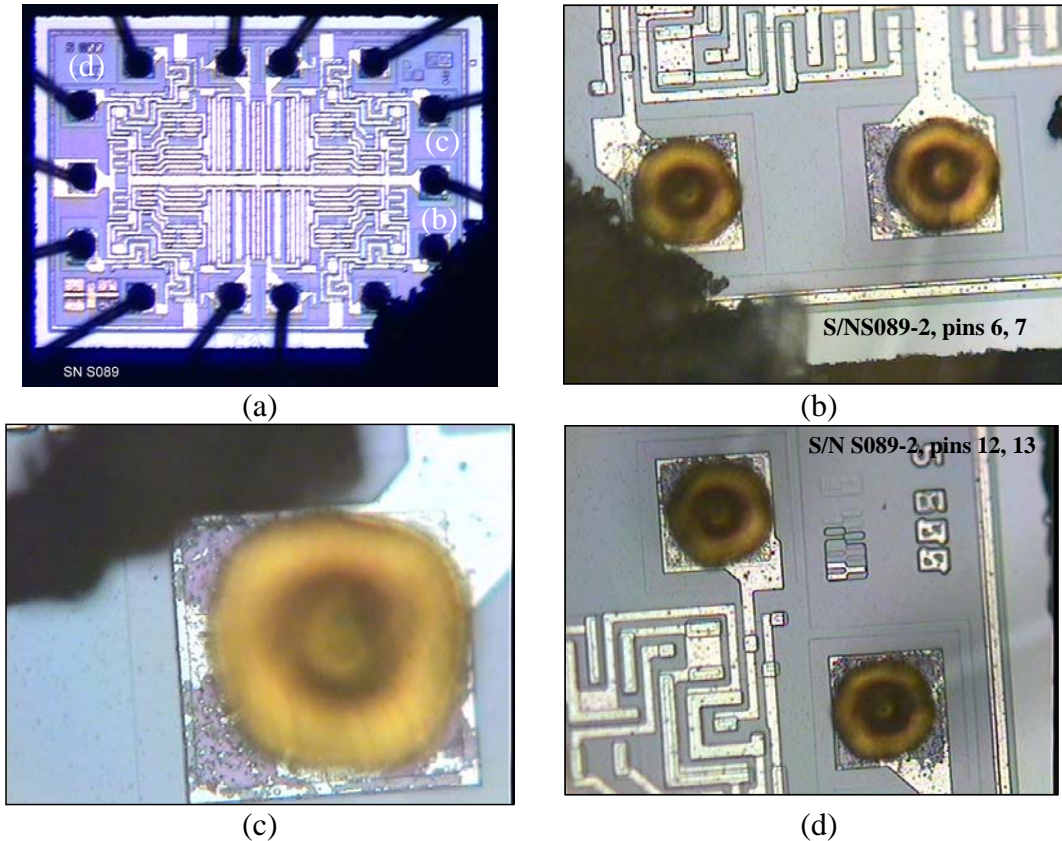
Figure 8 shows device S/N S089. Electrical testing resulted in output at pin 11 in the wrong state. Corrosion was found on all pins except 11 and 14. The extent of attack ranged from slight to severe. In some instances, the bondpad was almost completely consumed. No evidence of trace corrosion was seen.

Figure 8. Optical micrographs of Al bondpads for CD-4011 S/N S089. Extensive attack of the bondpad can be seen with corrosion progressing beneath the passivation layer. Pins 6, 7, 12, and 13 were attacked. Labels on the image in (a) indicate location for individual bondpads imaged in (b)-(d).

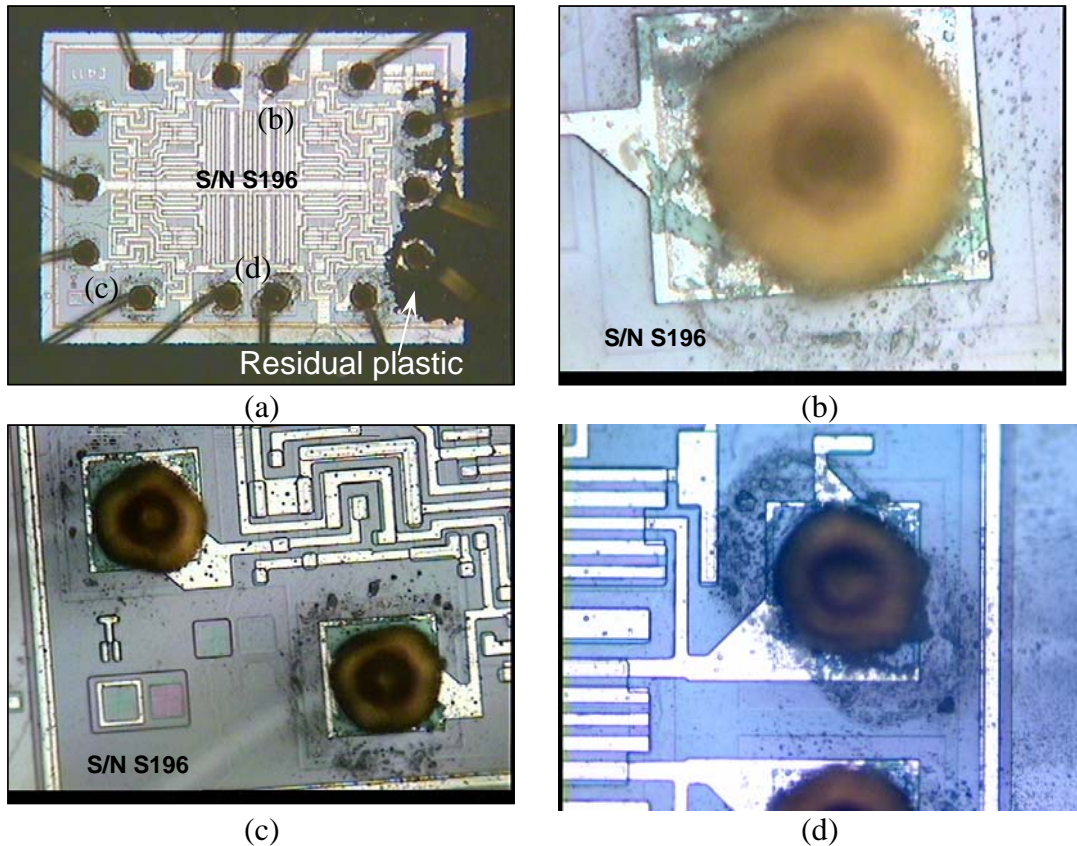
Figure 9 shows images from S/N S196. Pin 2 tested open during electrical testing. Corrosion was seen on all of the bondpads. The bondpad attack is visible, even on the low magnification image of the entire die. On some bondpads, the Al bondpad appeared to be totally consumed. In many areas, corrosion products are visible on the die surface around the bondpad.

Figure 9. Optical micrographs of Al bondpads for CD-4011 S/N S196. All bondpads exhibited some degree of attack. Labels on the image in (a) indicate location for individual bondpads imaged in (b)-(d).

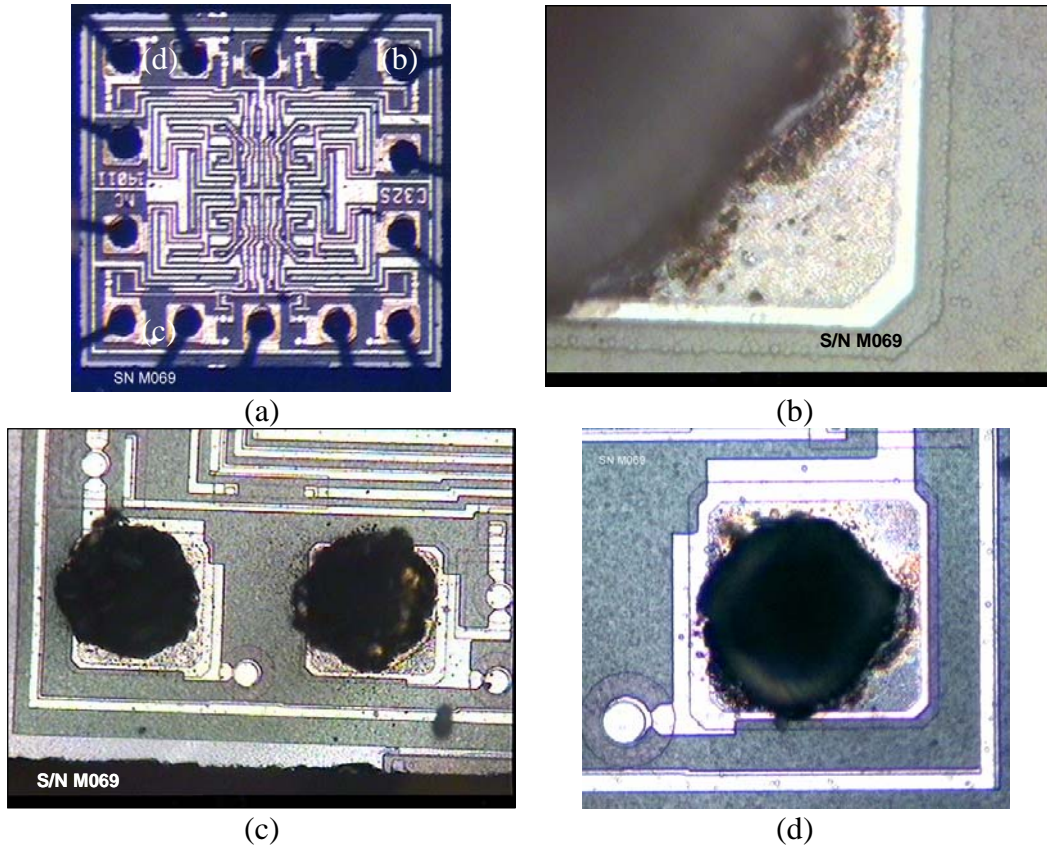
Figure 10 shows data for S/N M069. Pins 1,5, and 8 tested open. Corrosion was observed on pins 5, 6, and 9. The extent of visible corrosion was considerably lower on this device. In all cases, the majority of the Al bondpad was intact. The attack appeared to be concentrated around the edge of the gold ball. Otherwise, the die was clean, with no evidence of trace corrosion.

Figure 10. Optical micrographs of Al bondpads for CD-4011 S/N M069. Minor attack of the bondpad is visible. In addition, the rough material at the edge of the ball bond suggests formation of intermetallic compounds (ref. 1). Labels on the image in (a) indicate location for individual bondpads imaged in (b)-(d).

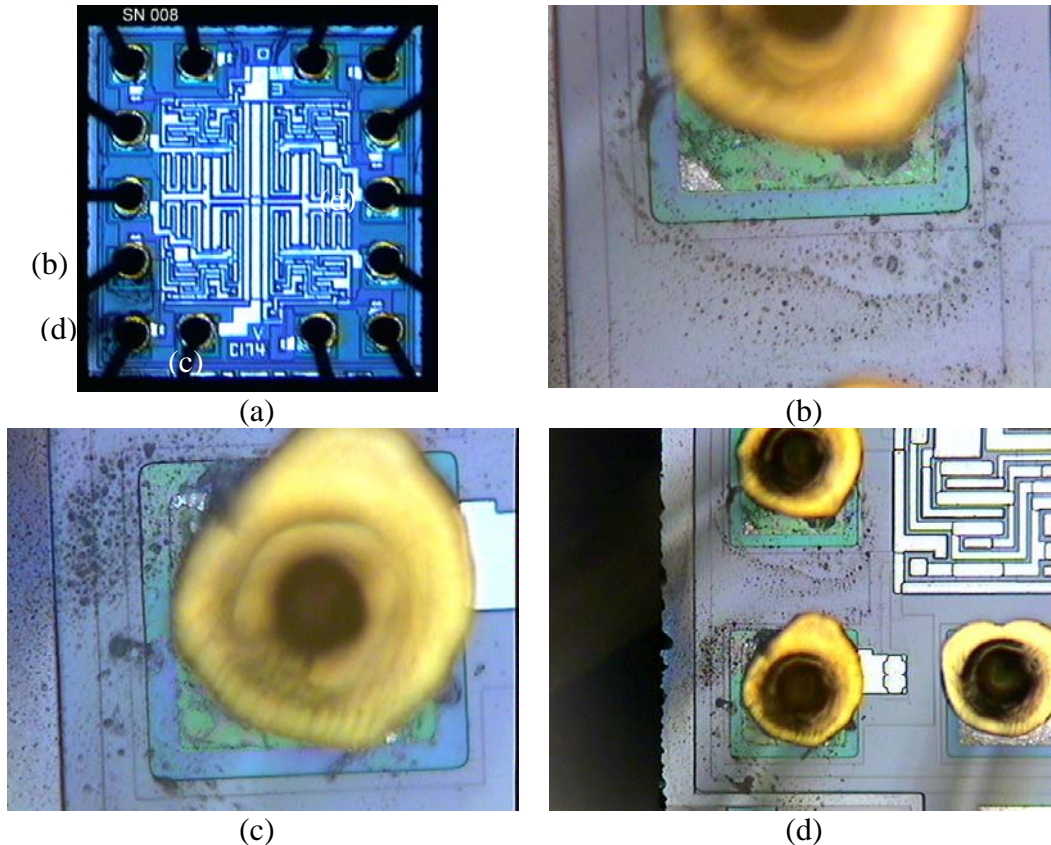
The last device examined was labeled SN 008. At this point the source of this part and the manufacturer are unknown. Based on the appearance of the die, it appears to be a Toshiba part. During testing and analysis, the identification was lost. Thus, the electrical response is unknown. This part exhibited extensive corrosion at several of the bondpads. In some instances, the entire Al bondpad had been consumed, with corrosion products visible on the die surface. Because the identification of this device is still unknown, it was not included in the failure rate data. During the next electrical testing sequence, an effort will be made to identify the source of SN 008.

Figure 11. Optical micrographs of Al bondpads for CD-4011 S/N 008. Severe attack of the bondpad is visible. In addition, corrosion products can be seen on the die surface. Labels on the image in (a) indicate location for individual bondpads imaged in (b)-(d).

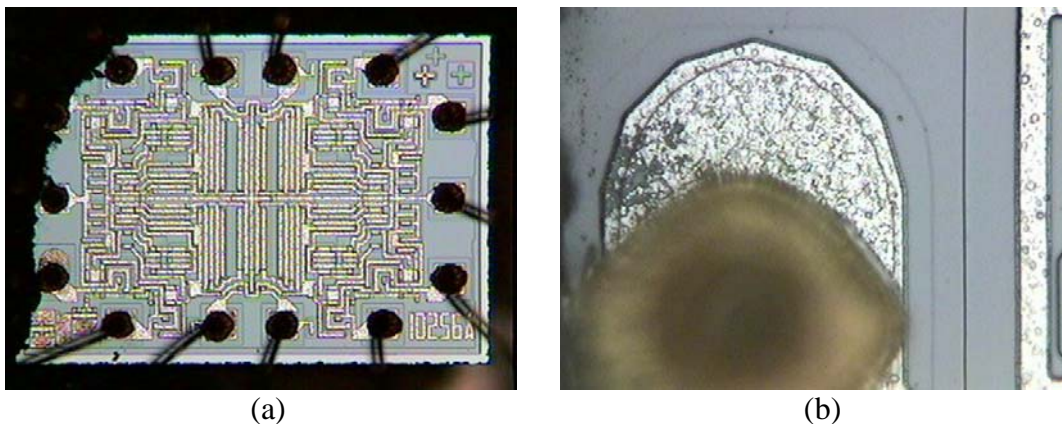
Figure 12 shows the die and bondpad for the Harris 59 device. Slight corrosion is seen on the bondpad, with no other evidence of attack.

Figure 12. Optical micrographs of Al bondpads for CD-4011 S/N H59. The die is generally healthy with a small amount of bondpad corrosion seen on pin 1.

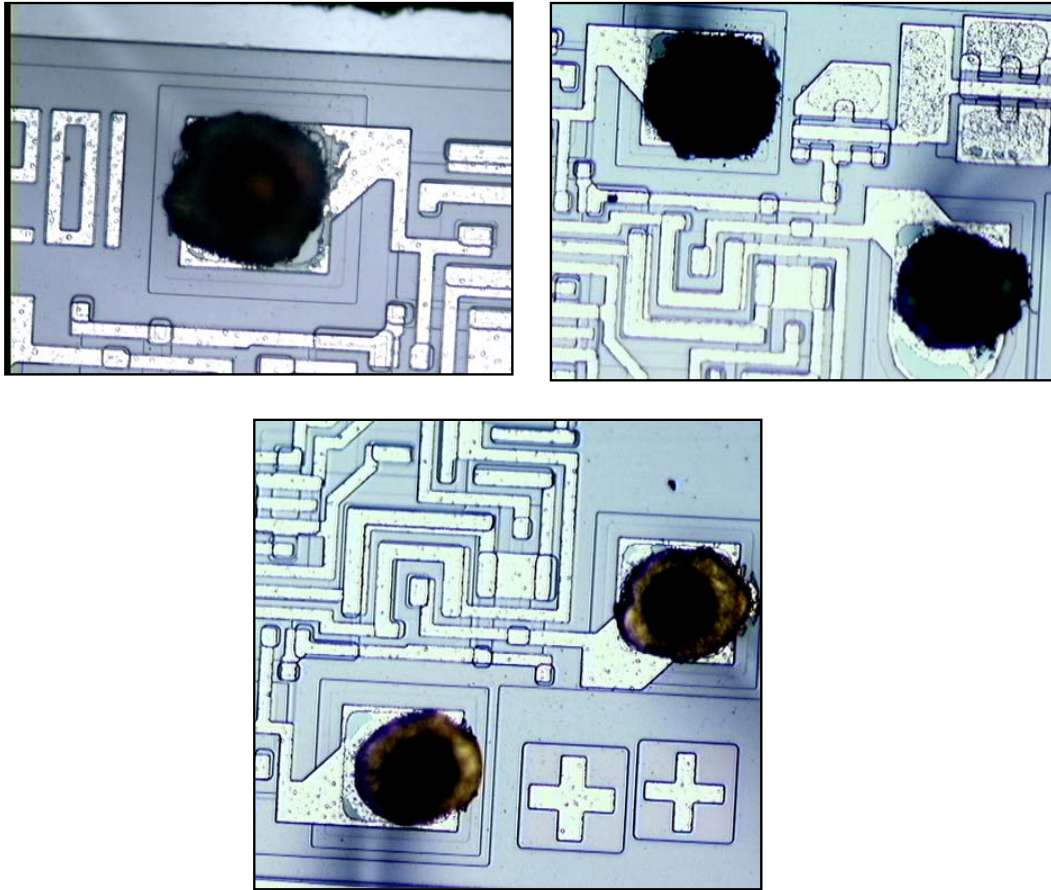
Figure 13 shows results for Harris SN 65. Attack was seen on pin 5 and 6. Although the attack was not extensive, it is possible that it was concentrated at the Au/Al interface, resulting in isolation of the Au wire and electrical open at that point.

Figure 13. Optical micrographs of Al bondpads for CD-4011 S/N H65. The die is generally healthy with a small amount of bondpad corrosion seen on several bondpads.

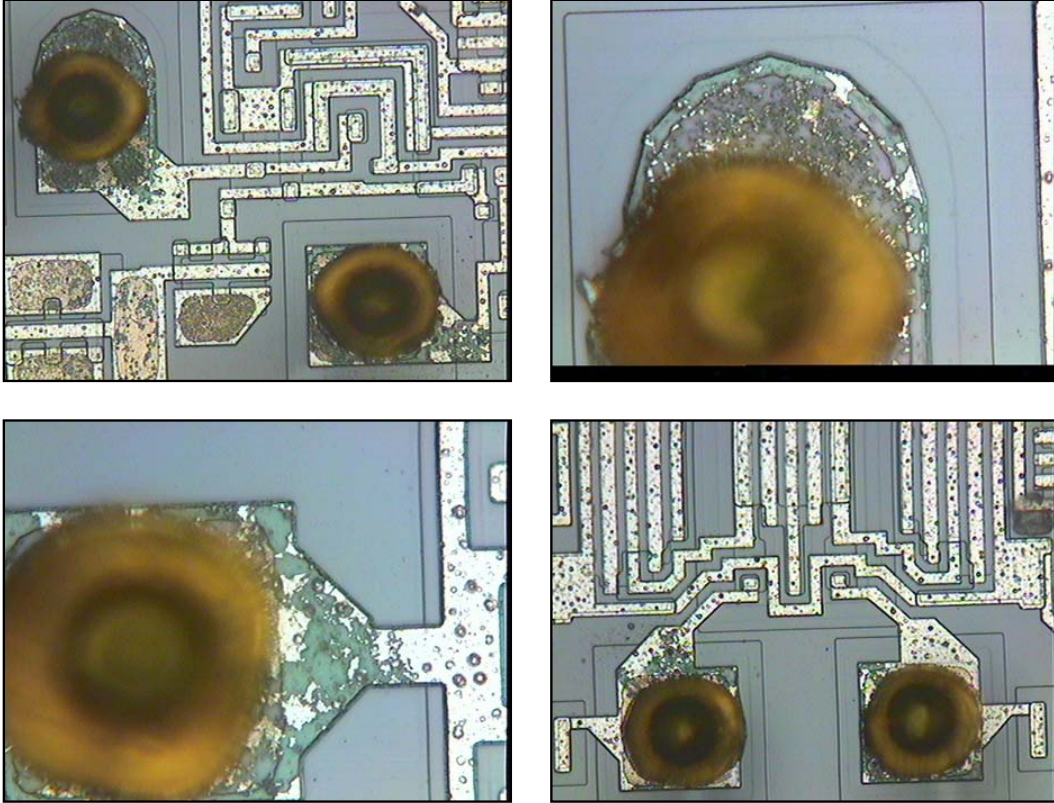
Figure 14 presents results from Harris 43. Corrosion was observed on multiple bondpads. The attack is quite severe, with substantial Al missing from several of the bondpads. In some cases (e.g. Figure 14c), corrosion has progressed from the bondpad into the trace (beneath the passivation layer) connected to the bondpad.

Figure 14 Optical micrographs of Al bondpads for CD-4011 S/N H43. Substantial corrosion can be seen on several bondpads, with some evidence of attack of the Al traces.

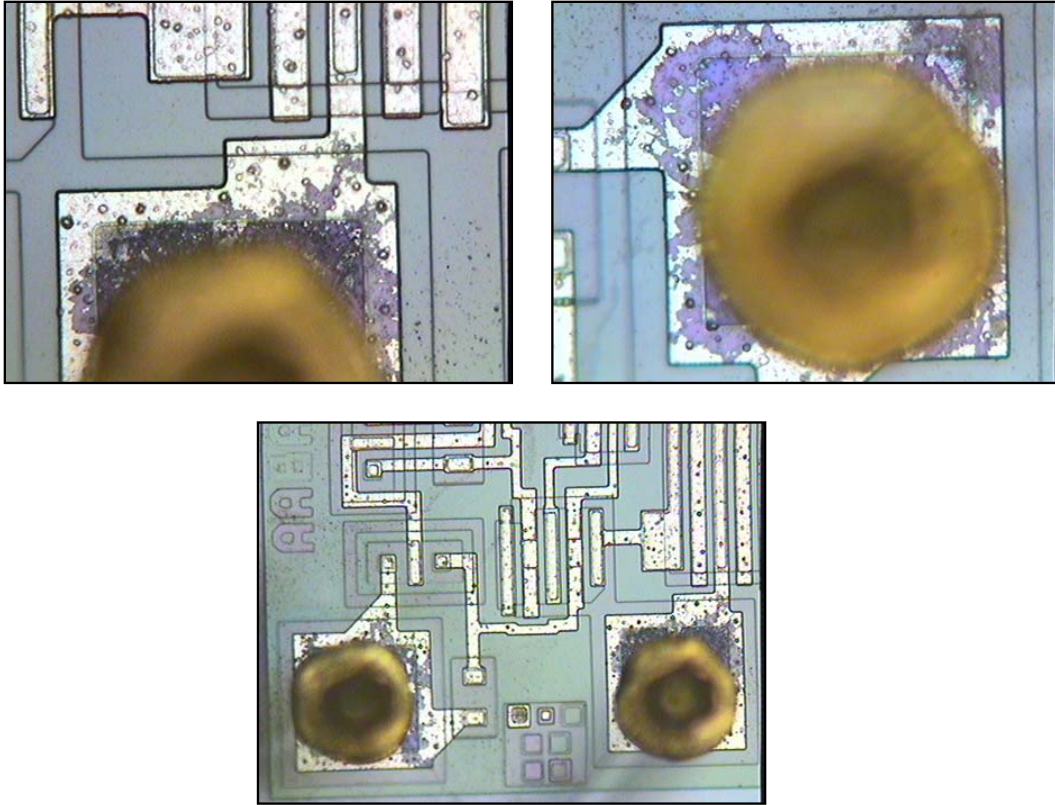
Figure 15 shows results from National 38. Corrosion was observed on multiple bondpads. In some instances, it penetrated further beneath the passivation layer and attacked the adjacent Al. The extent of attack is certainly significant enough to result in electrical failure of the part. No attack of the traces was observed.

Figure 15. Optical micrographs of Al bondpads for CD-4011 S/N N38. Substantial corrosion can be seen on several bondpads.

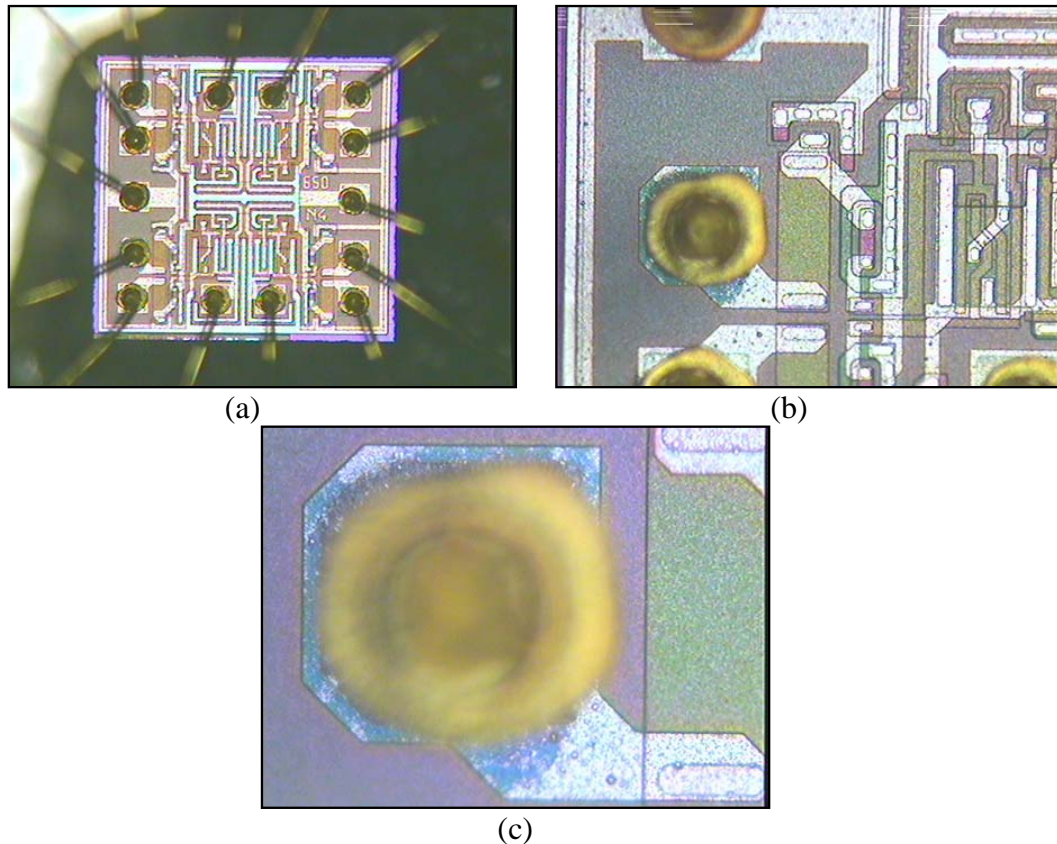
Figure 16 shows micrographs for Philips 43. Corrosion was observed on pin 1. Significant attack of the bondpad can be seen. Other bondpads did not appear to be corroded. In addition, there was no evidence of trace corrosion.

Figure 16. Optical micrographs of Al bondpads for CD-4011 S/N P43. Die is generally healthy (a) and (b). Some attack can be seen on pin 1 (c).
